A PROJECT REPORT ON

LAND SUBSIDENCE AND STRUCTURAL COLLAPSE OF JOSHIMATH, UTTARAKHAND

PAPER NAME-DISASTER MANAGEMENT BASE PROJECT WORK

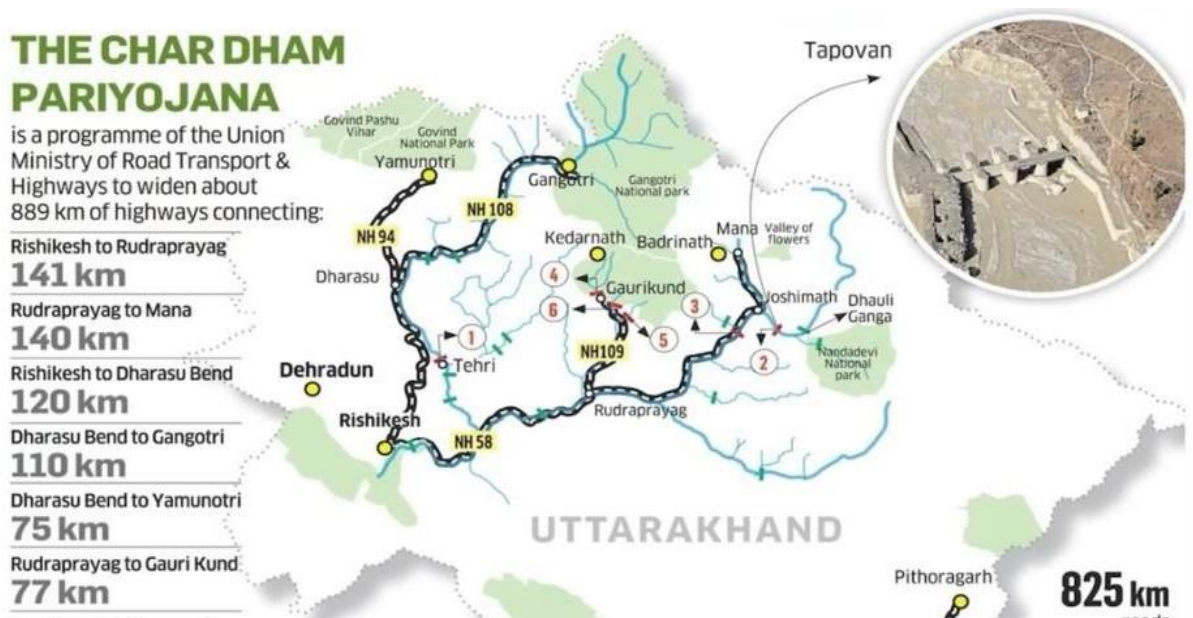
THE CHAR DHAM PARIYOJANA

is a programme of the Union Ministry of Road Transport & Highways to widen about 889 km of highways connecting:

The widening of the road was not just a big contributor, but also led to more and more hotels springing up in and around Joshimath. The roads in such geologically sensitive region should have been seven metres wide, but the government widened the roads to 12 metres²³, which led to more and more cleaning of the hills. This made the already ecologically sensitive region highly vulnerable to landslides as the top layer was cleaned for the road construction.

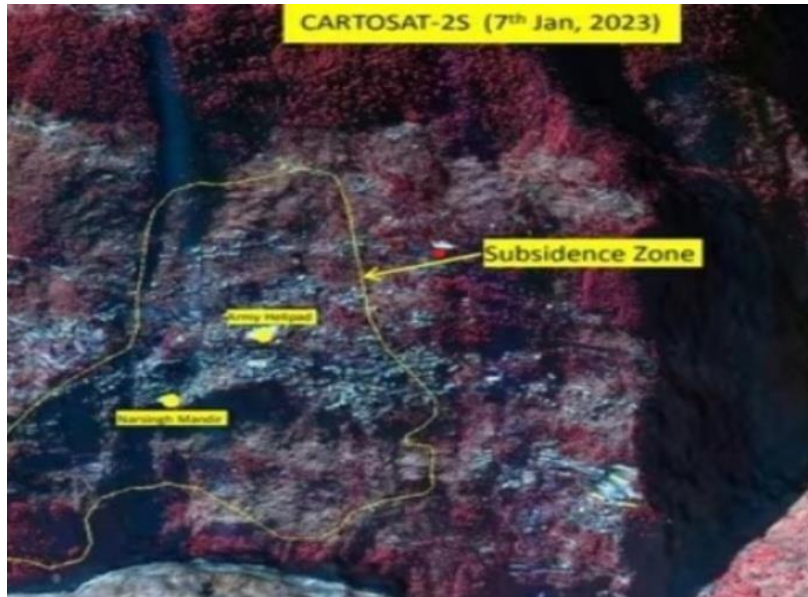
A preliminary study by the Indian Space Research Organisation’s National Remote Sensing Centre found that land subsidence was “slow” between April and November 2022, with Joshimath sinking by 8.9 cm. However, between 27 December 2022 and 8 January 2023 (a 13-day period of “rapid subsidence”), the town sank by 5.4 cm. The report suggested that the entire town may face an existential threat due to land subsidence.^[11] Some environmentalists have suggested that other human settlements in the region could also soon face a similar crisis.^[12]

Satellite photographs captured by the Cartosat-2S satellite and issued by the National Remote Sensing Centre (NRSC) of the Indian Space Research Organisation (ISRO) have revealed that Dehradun Joshimath may soon face complete submersion due to land subsidence. The images, which show sinking regions of the town, have been made public by the

The region subsided around 5 cm within a span of a few days and the areal extent of subsidence has also increased. But it is confined to the central part of Joshimath town,” the NRSC report said. It said a subsidence zone resembling a generic landslide shape was identified – tapered top and fanning out at base. The report noted that the crown of the subsidence was located near Joshimath- Auli road at a height of 2,180 metres.

According to images released by the National Remote Sensing Centre of the Indian Space Research Organisation, Uttarakhand’s Joshimath has witnessed a rapid subsidence of nearly 5.4 cm in the past 12 days. The report stated that a subsidence of nearly 9 cm was recorded between April-November 2022.
