DEPARTMENT OF GEOGRAPHY

A PROJECT REPORT ON

LAND SUBSIDENCE AND STRUCTURAL COLLAPSE OF JOSHIMATH, UTTARAKHAND

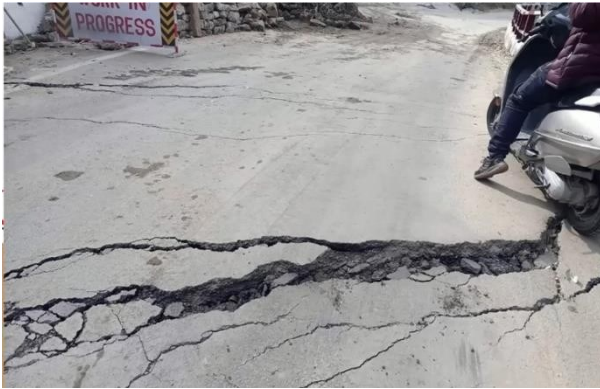
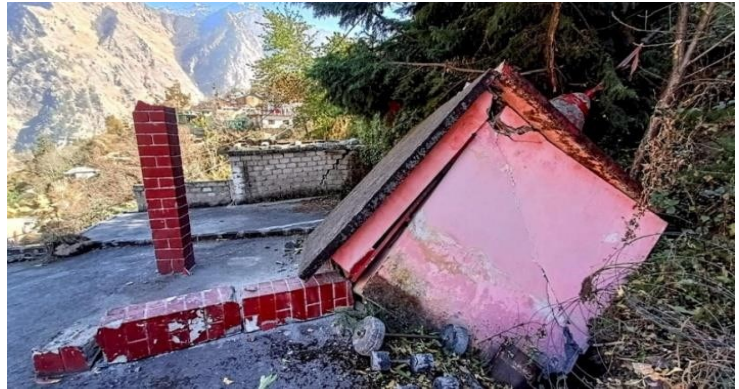
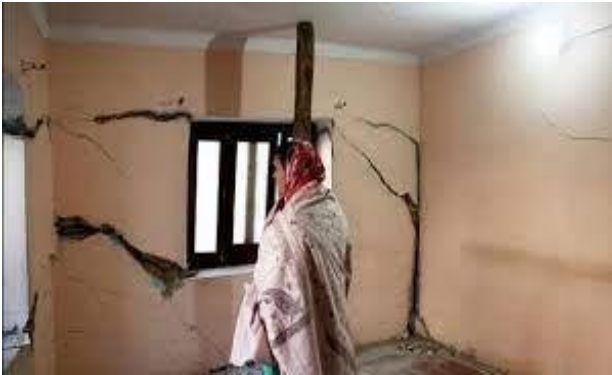
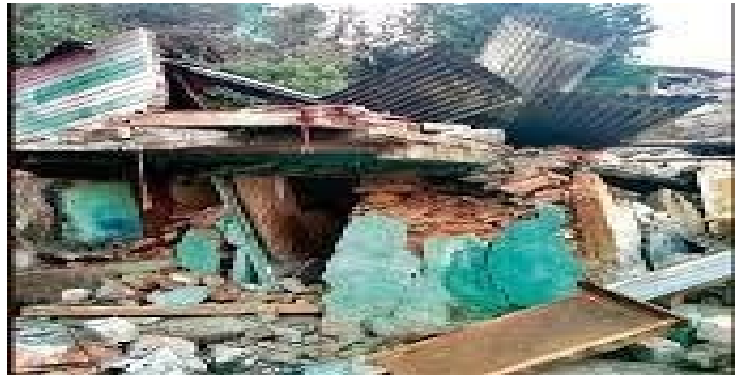
Since early January 2023, Joshimath—a small town in the Chamoli district of Uttarakhand—has become a ‘sinking town’, with residential and commercial structures and road infrastructure developing cracks and many areas becoming unlivable or unusable. Joshimath has since been declared a “disaster-prone area”¹⁸As a result, the state government banned further construction in and around the town, and ordered the evacuation of more than 600 families from the danger zones.^[4]Additionally, several structures were demolished for being “unsafe”¹⁹.

. It was found that a gradual settling or sudden sinking of the earth's surface due to the removal or displacement of subsurface materials — has induced structural defects and damage in almost all wards of the city.

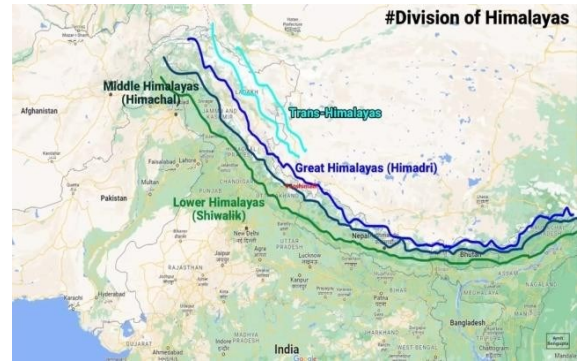
- Joshimath, as found by the geologists, are lying on ancient glacial debris (accretionary wedge) formed as a result of convergence of Indian Plate with the Eurasian plate. Located at the Middle Himalaya region, the town of Joshimath, is formed from loose debris which eventually compacted to form a landmass. Joshimath was always vulnerable to earthquakes as the region falls in the seismic zone V. The weak foundation of the city due

to its sitting atop a glacial moraine, which is distinct ridges or mounds of debris that are laid down by a glacier, the town's foundation has no solid rocks.

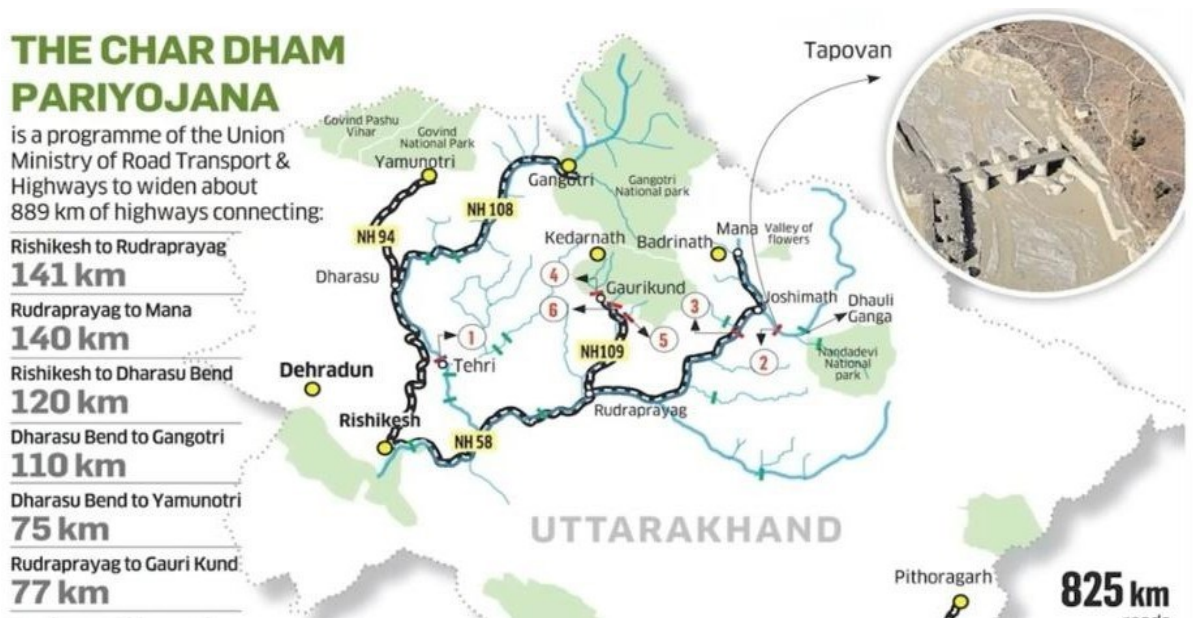
THE CHAR DHAM PARIYOJANA

is a programme of the Union Ministry of Road Transport & Highways to widen about 889 km of highways connecting:

The widening of the road was not just a big contributor, but also led to more and more hotels springing up in and around Joshimath. The roads in such geologically sensitive region should have been seven metres wide, but the government widened the roads to 12 metres²³, which led to more and more cleaning of the hills. This made the already ecologically sensitive region highly vulnerable to landslides as the top layer was cleaned for the road construction.

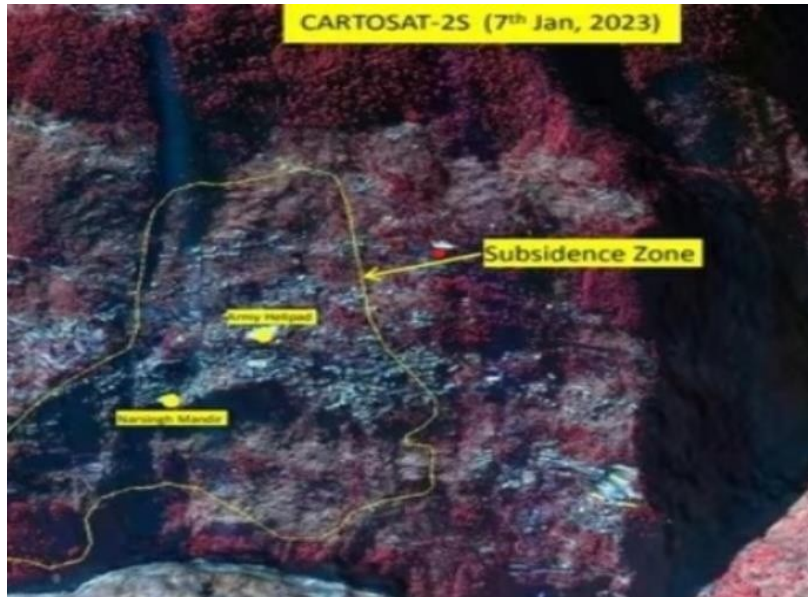
A preliminary study by the Indian Space Research Organisation’s National Remote Sensing Centre found that land subsidence was “slow” between April and November 2022, with Joshimath sinking by 8.9 cm. However, between 27 December 2022 and 8 January 2023 (a 13-day period of “rapid subsidence”), the town sank by 5.4 cm. The report suggested that the entire town may face an existential threat due to land subsidence.^[11] Some environmentalists have suggested that other human settlements in the region could also soon face a similar crisis.^[12]

Satellite photographs captured by the Cartosat-2S satellite and issued by the National Remote Sensing Centre (NRSC) of the Indian Space Research Organisation (ISRO) have revealed that Dehradun Joshimath may soon face complete submersion due to land subsidence. The images, which show sinking regions of the town, have been made public by the

Hyderabad-based NRSC, designating the entire town as a sensitive zone, including the Army's helipad and the Narasimha temple. As a result of ISRO's preliminary report, According to a report from the Indian news agency IANS on January 13th, the government of Uttarakhand is undertaking rescue operations in high-risk areas and evacuating residents to safer locations as quickly as possible.

The region subsided around 5 cm within a span of a few days and the areal extent of subsidence has also increased. But it is confined to the central part of Joshimath town,” the NRSC report said. It said a subsidence zone resembling a generic landslide shape was identified – tapered top and fanning out at base. The report noted that the crown of the subsidence was located near Joshimath- Auli road at a height of 2,180 metres.

According to images released by the National Remote Sensing Centre of the Indian Space Research Organisation, Uttarakhand’s Joshimath has witnessed a rapid subsidence of nearly 5.4 cm in the past 12 days. The report stated that a subsidence of nearly 9 cm was recorded between April-November 2022.
